Jagersfontein Dam Collapse

VS 14.09.2022

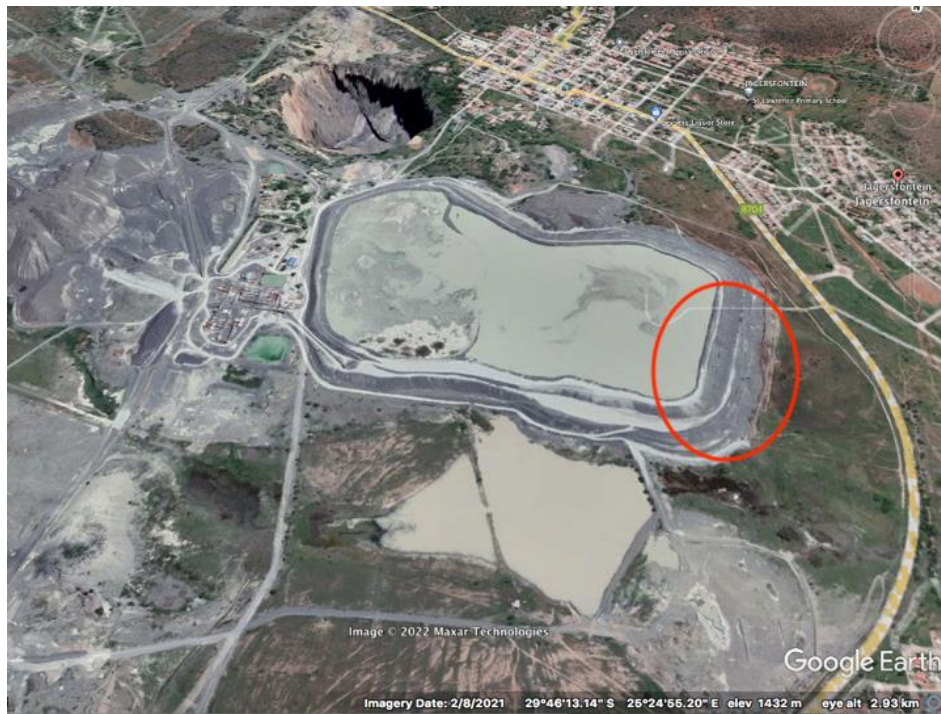
The Jagersfontein TSF as per February 2021

1. In the first instance, in the google earth image - the latest available image is from February 21 - we observed an extremely watery dam which has also led us to measure the height of the free board. To our surprise - and aware that only digital photogrammetry can give us a more precise measurement than the generic google earth ones - we noticed that the free board is non-existent in several sections of the perimeter of the containment. In short, in some stretches the level of the deposit, saturated with water, appears to reach the level of the dam's crown. If this circumstance corresponds to reality, we are facing an enormous and unacceptable risk aggravation.

3. In the first image we can also observe an accumulation of water at the base of the slope, which may be the result of over-topping or, more likely, seepage, which was then controlled by widening the slope. If this was the case, the measure would be highly questionable, since seepage is not controlled by simply adding thickness to the structure. This aspect alone indicates the complexity of a TSF (Tailing Storage Facility), which requires detailed attention from its design and construction: site preparation, up-lifting, use of suitable material and its treatment for the slopes, as well as a well-defined strategy for the up-lifting of the boards and/or containment slopes.

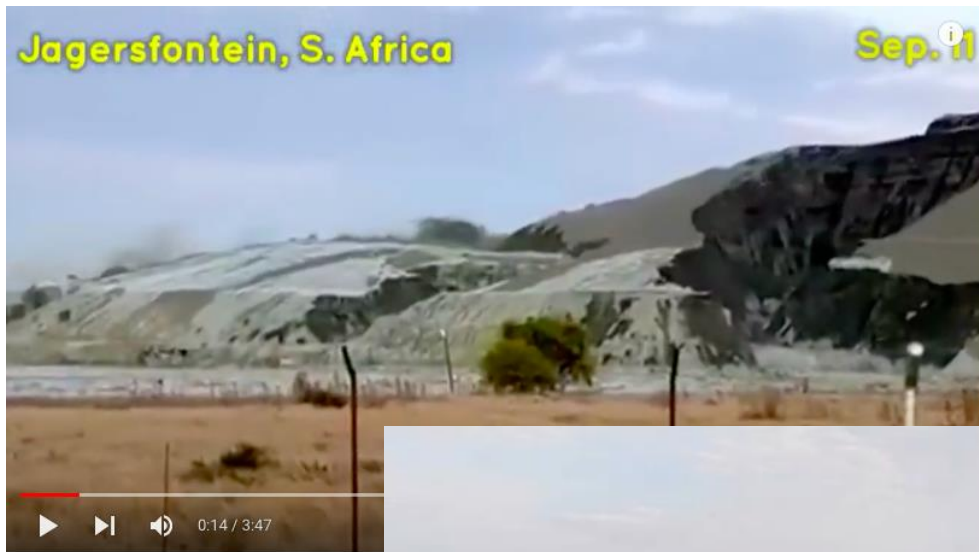
#worldisdangerous #dam #flooding
Flooding caused by mine dam collapse

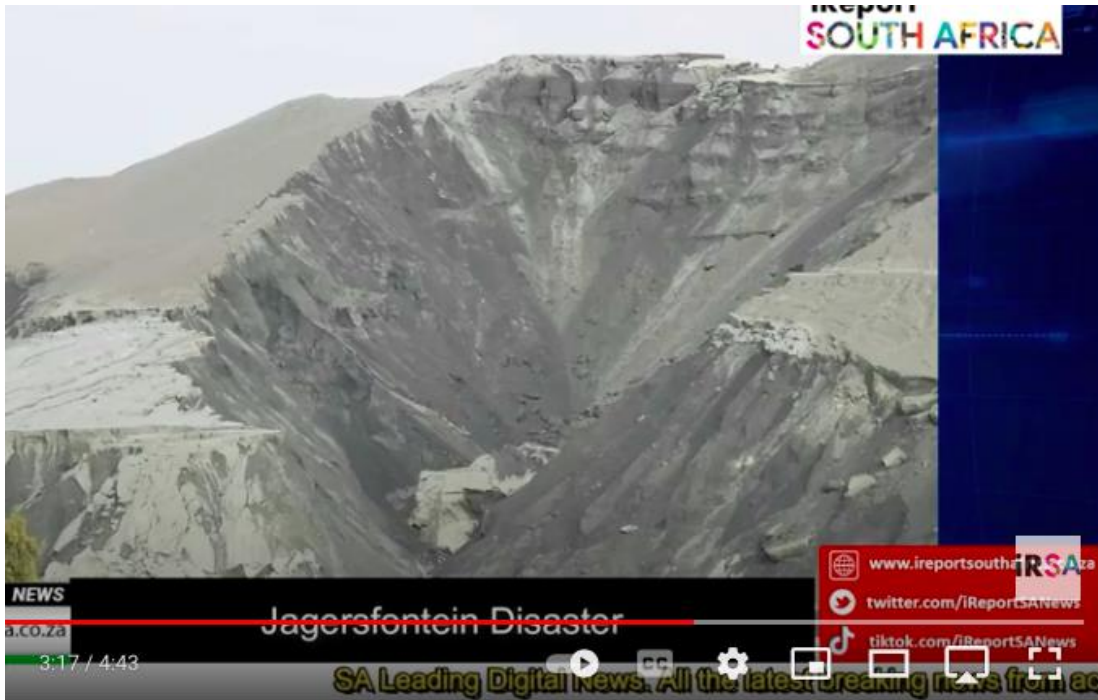
A saturated embankment can be observed

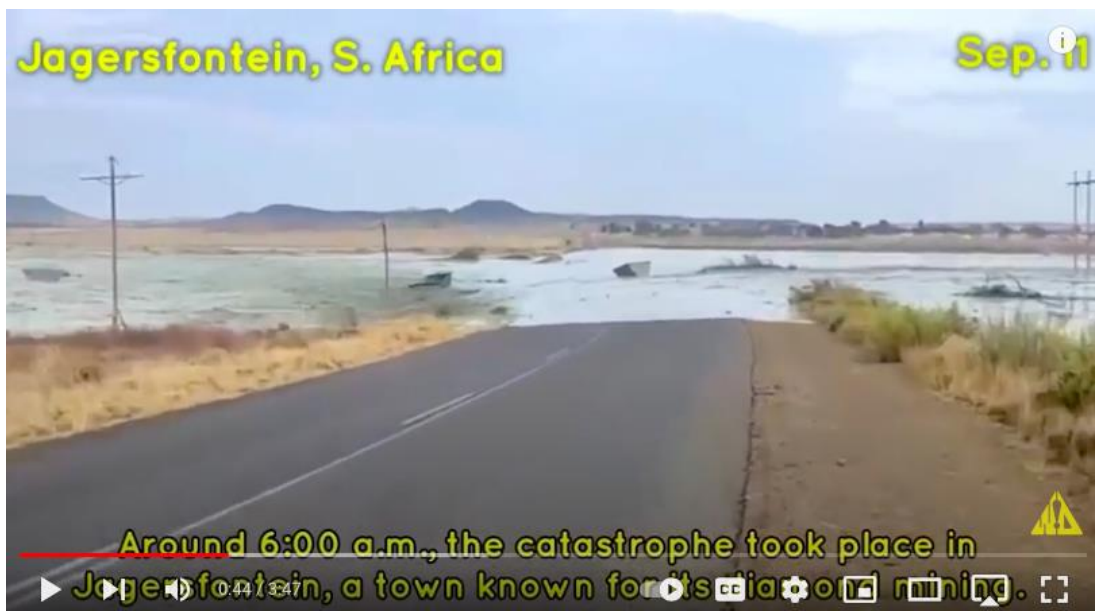
The flooding crossed an important highway

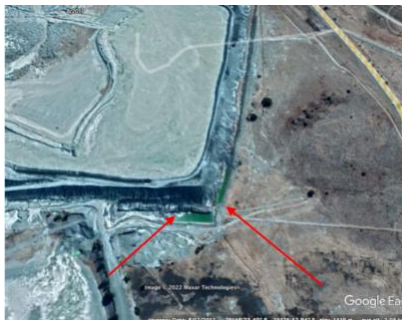
Image 8/2017

2. Google earth allows us to view images from previous years. We have viewed images from 2017 and 2019 of the same area of the TSF and we can see that the base of the southeast slope of the dam has been reinforced, that is, exactly at the point where the structure failed.

The images indicate that there may have been a history of weakness in the area that has now collapsed.
