Jagersfontein Dam Collapse

VS 14.09.2022

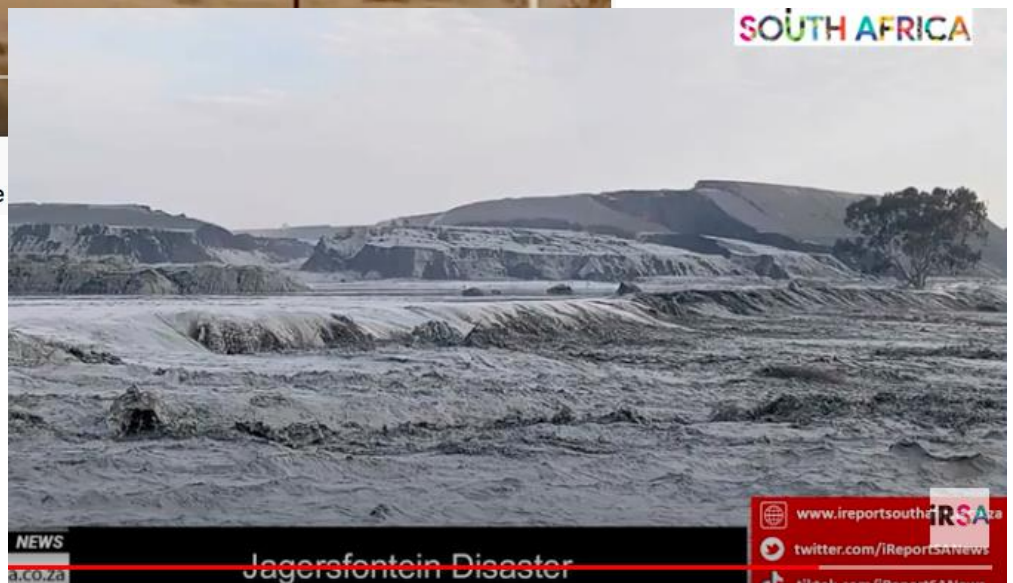
#worldisdangerous #dam #flooding
Flooding caused by mine dam collapse

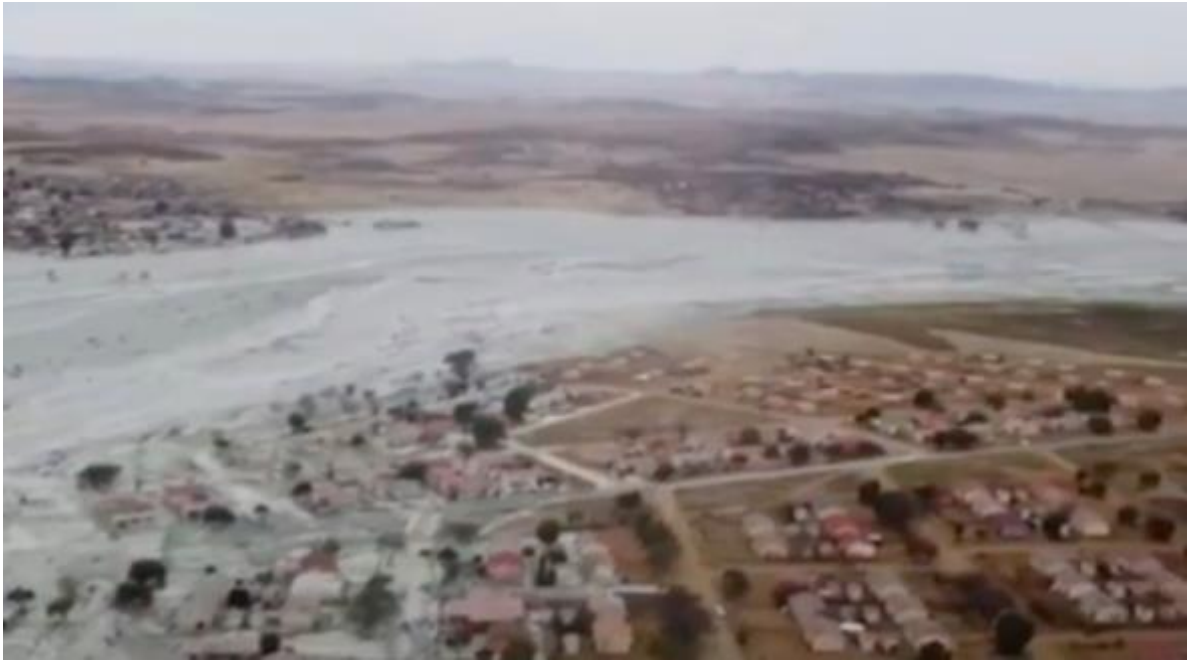
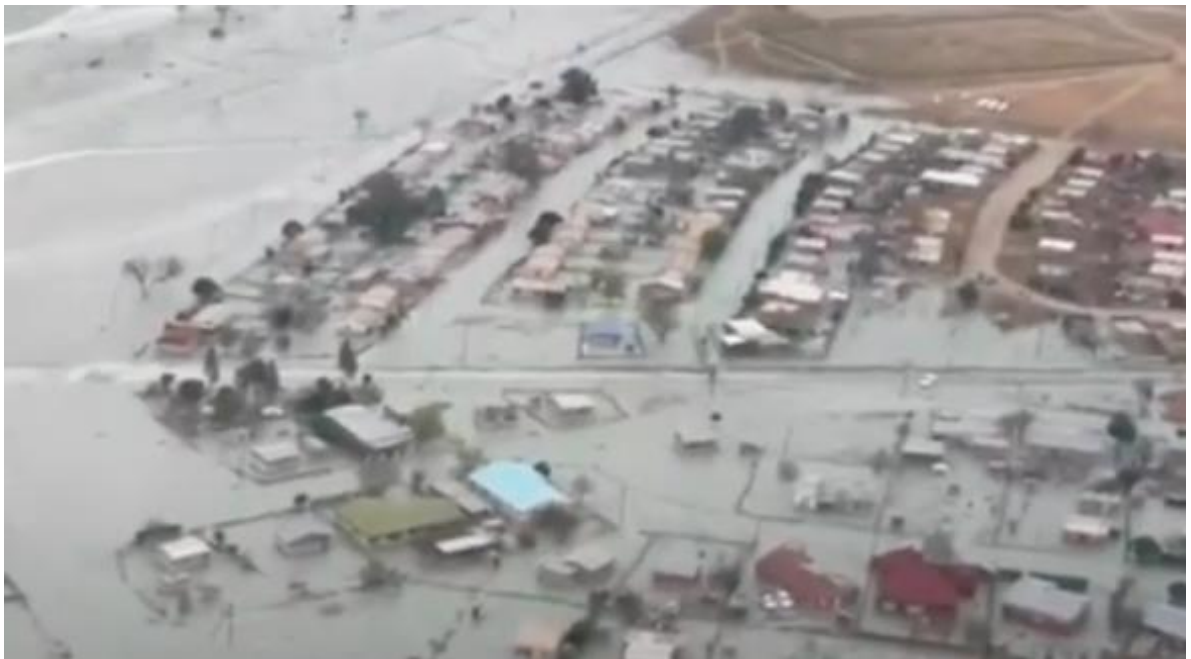
A grey sludge covers roads in Jagersfontein after a mining dam burst on 11 September 2022. Picture: @NationalCoGTA/Twitter
